1 National Transportation Safety Board

5
6
7
8 Group Chairman's Factual Report

9
10
11
12
13 Survival Factors Group
14
15
16
17
18

19 *El Faro*

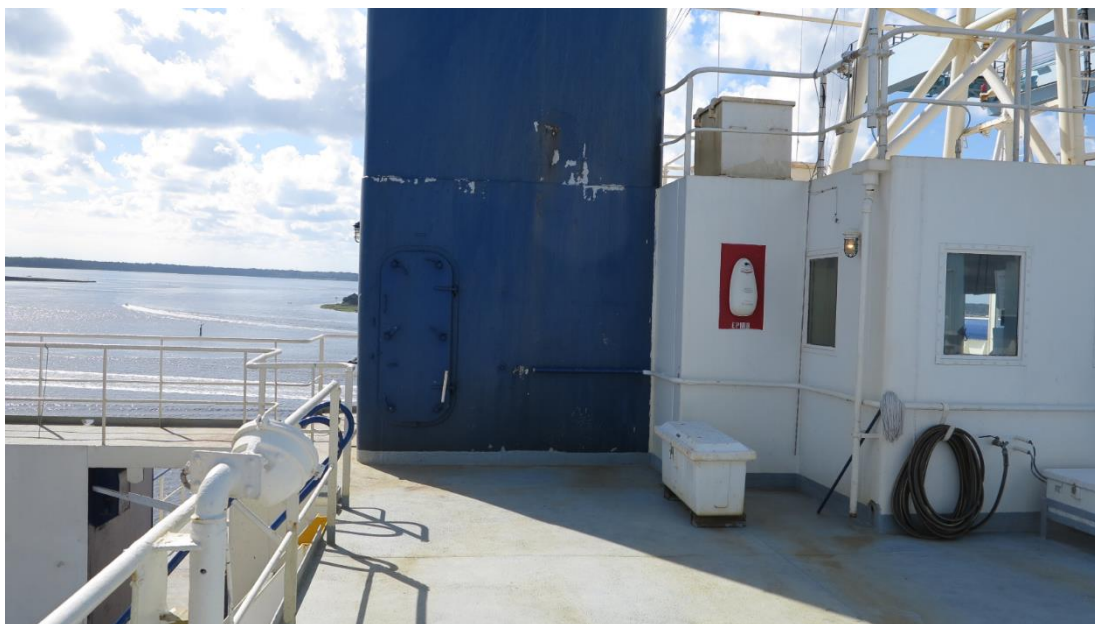
1 Low-altitude, near-polar-orbiting satellites detect doppler shift to determine the location of an
2 EPIRB.¹⁶ *El Faro*'s EPIRB model did not have a built-in GPS, so the alert was received and forwarded as
3 a "406 beacon unlocated first alert" message. The message was automatically processed at 0739 (1139
4 UTC) and sent as an email to D7CC. No further *El Faro* communications were received by the Coast
5 Guard or TOTE. Figure 4 shows the location of the EPIRB on *El Faro*'s sister ship *El Yunque*.

6
7 **Figure 4.** *El Yunque*'s JOTRON 406 MHz satellite EPIRB in its stowed position on painted red
8 background, aft of bridge on starboard side and forward of blue stack.

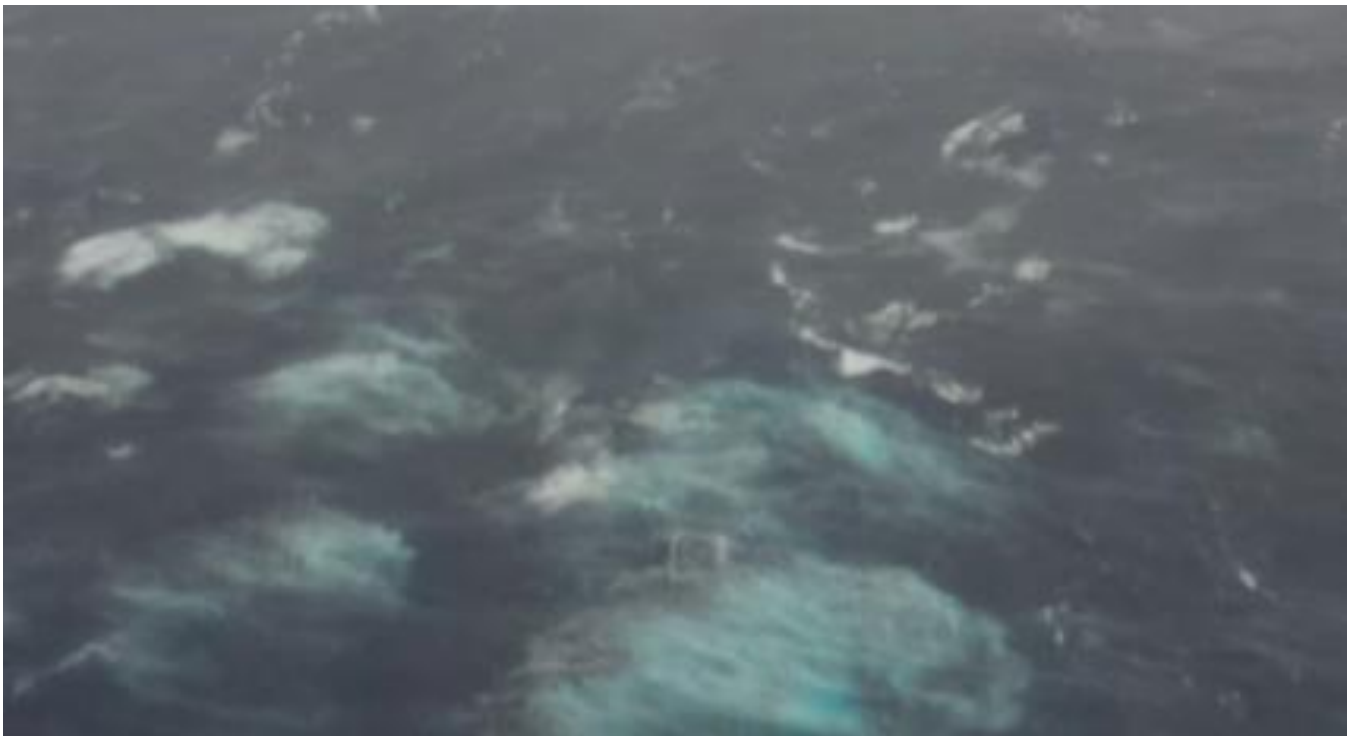
9
10 **Figure 7.** CG1503, a Coast Guard C-130 aircraft based at Air Station Clearwater, took this photo at an
11 altitude of 500 feet showing challenging search conditions—20 to 40 foot swells—on October 3. (Coast
12 Guard photo)

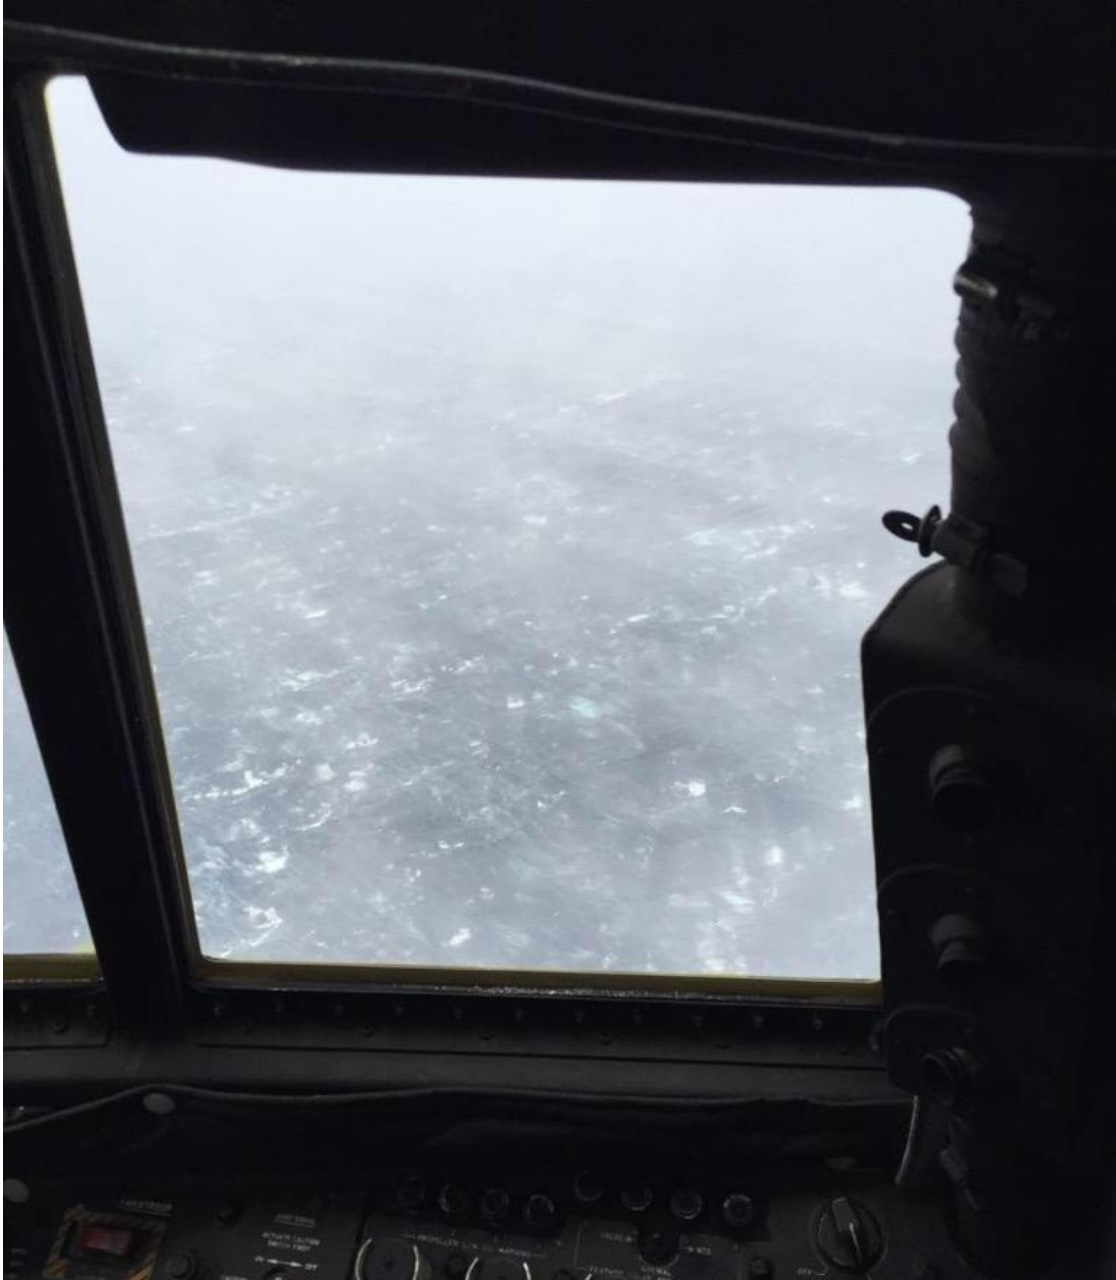
Figure 8. CG1503, a Coast Guard C-130 aircraft based at Air Station Clearwater took this photo at an altitude of 500 feet showing challenging search conditions on October 3, when hurricane-force winds caused significant sea spray and whitecaps. (Coast Guard photo)

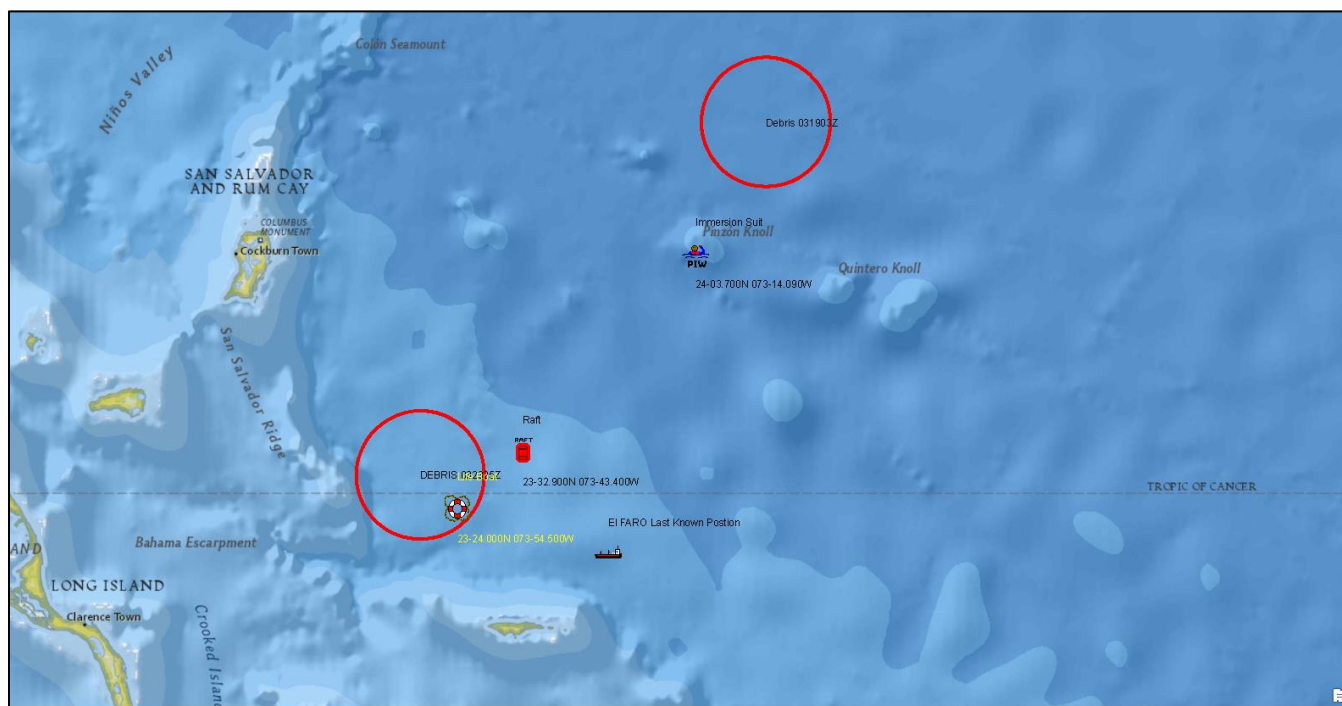
reported immersion suit and at sunset, returned to attempt to recover the remains. The crew was unable to relocate the remains.²⁸ The helicopter aborted the search at darkness, and the *Northland* went to the scene to search throughout the night. The immersion suit with human remains was never recovered. Figure 11 shows the location of the *El Faro* debris fields and objects discovered during SAR operations.

Figure 11. Last known position of *El Faro* (ship symbol) and two debris fields²⁹ (red circles). First debris field was located bearing 293° true at 31 nm from the last known position; second debris field was located bearing 020° true at 72 nm from *El Faro*'s last known position. Each debris field had a radius of about 10 nm; the distance between the debris fields was 76 nm. Major survival gear found were lifeboat (lifering symbol), liferaft (red raft symbol), and immersion suit with human remains (PIW symbol). (Coast Guard graphic)

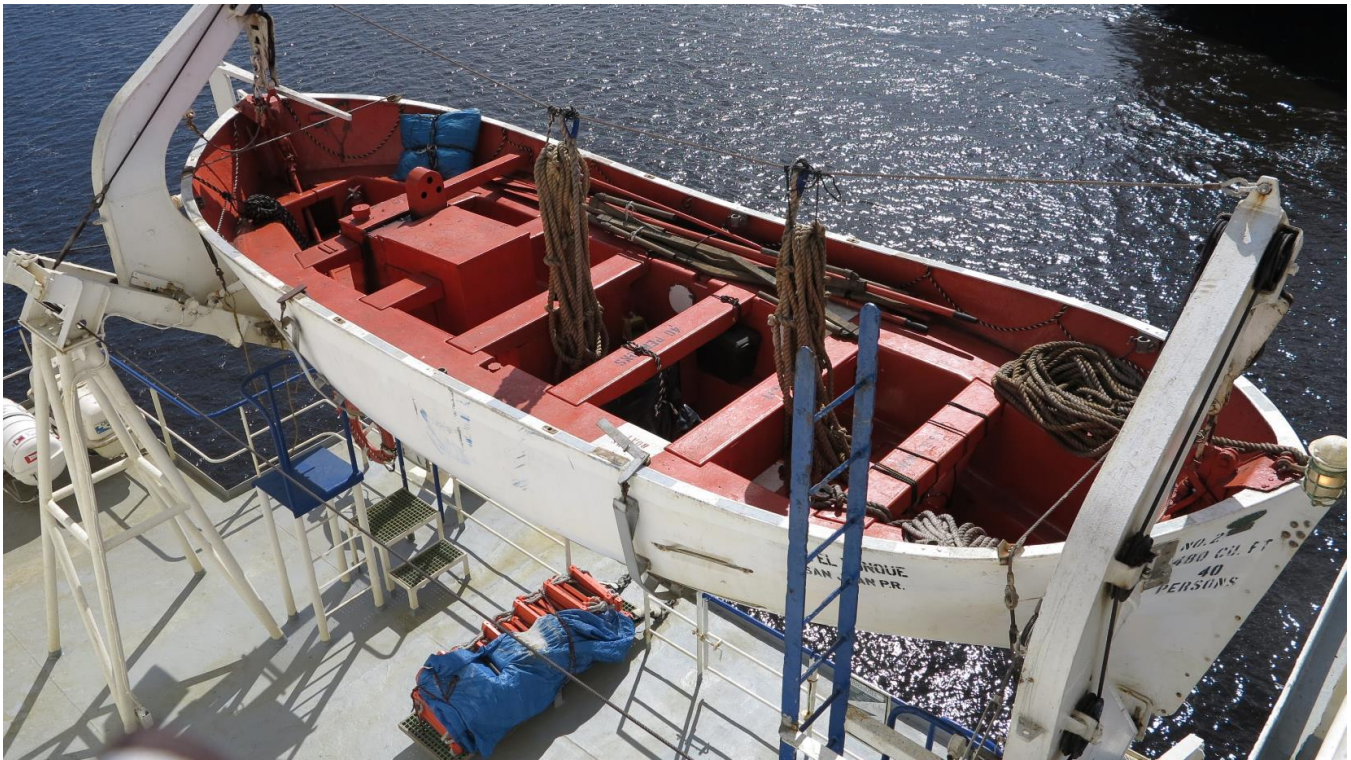
The diesel-operated port lifeboat, MASECO boat number 2412, was not found during the 7 days of *El Faro* recovery operations. During the first VDR search mission, the wreckage of *El Faro* was examined. Investigators noted that the lifeboat was not in its davit (for comparison, figure 19 shows the sister ship *El Yunque*'s port lifeboat in stowed position).

Figure 19. *El Yunque*'s port lifeboat in stowed position.

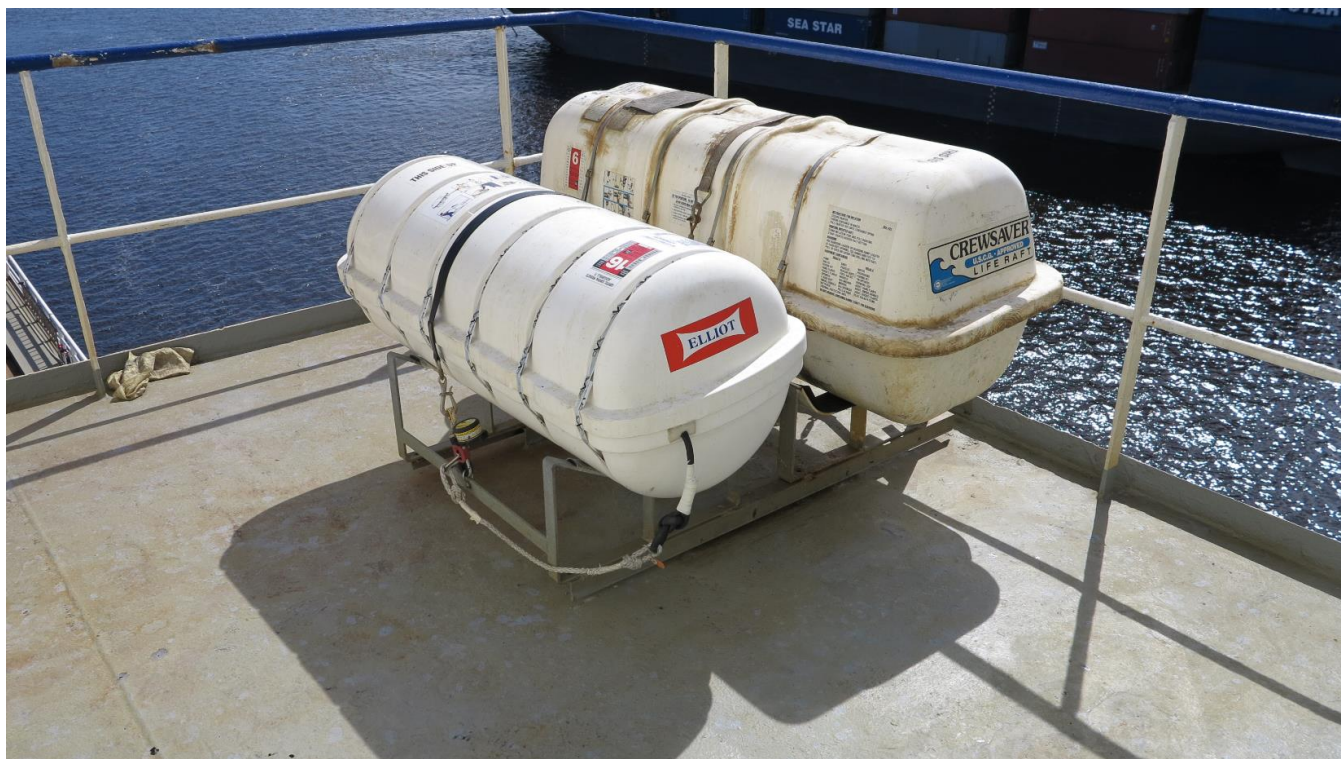
The vessel carried two extra 25-person liferafts. According to TOTE, the extra liferafts were put onboard *El Faro* as a precaution after corrosion was found on the *El Yunque*'s gravity davits and in case a similar situation should arise on *El Faro*. Both liferafts were Elliot SOLAS Style Mk IV TO (liferaft 4, serial no. 5086300200735, and liferaft 5, serial no. 5086300200613).⁴⁹ The liferafts were manufactured in July 2015 and thus in their first 2 years of service. They were not due for service until July 7 and July 27, 2017, respectively. Figure 24 shows two stowed liferafts on the sister ship *El Yunque*.

Figure 24. Two liferafts stowed in cradles aft of *El Yunque's* number 2 (port) lifeboat.

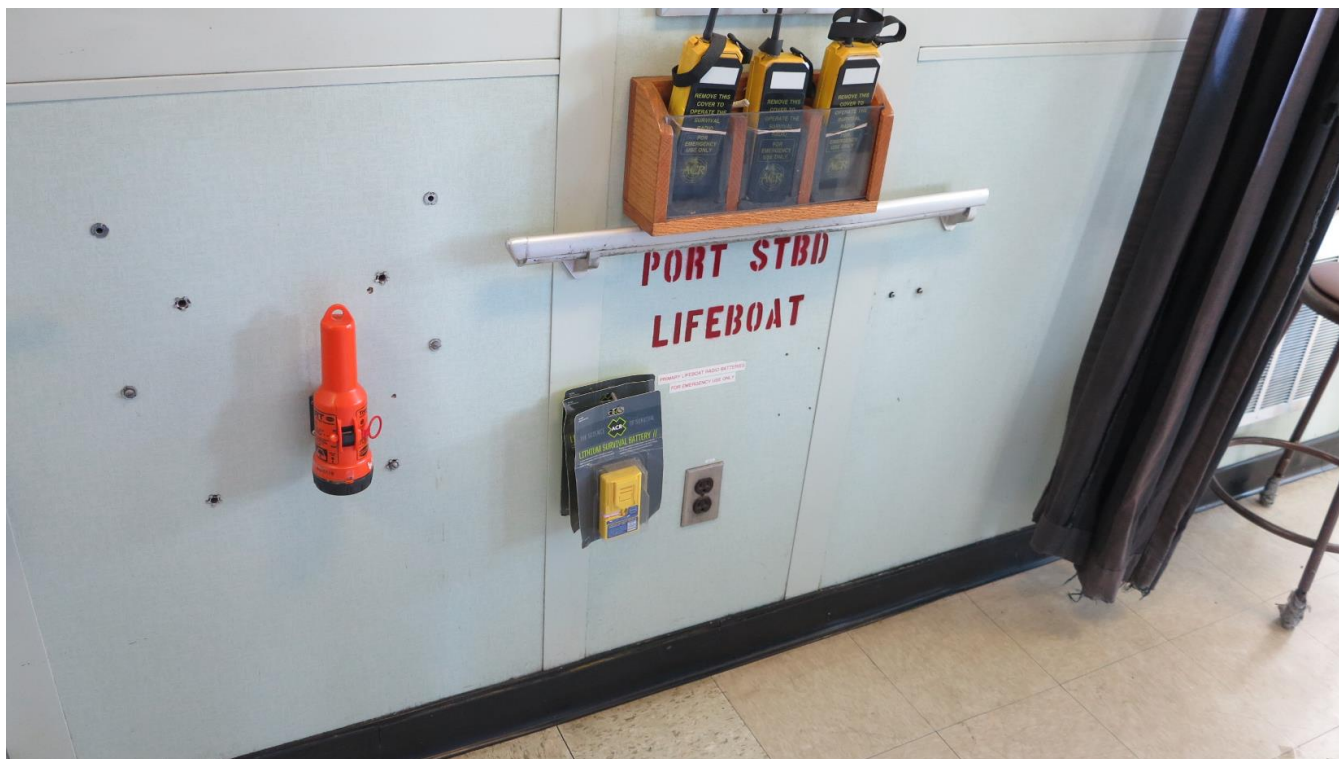
6 ship *El Yunque*. Figure 29 shows the location of the SART beacon, GMDSS radios, and extra batteries on

Figure 29. Pictured on *El Yunque*'s bridge are from left, orange 9 GHz (SART) beacon, three 2-channel VHF GMDSS survival (lifeboat) radios, and extra batteries below.
